INDOOR AIR QUALITY ASSESSMENT

Prescott Elementary School 145 Main Street Groton, Massachusetts

Prepared by:
Massachusetts Department of Public Health
Center for Environmental Health
Emergency Response/Indoor Air Quality Program
March 2007

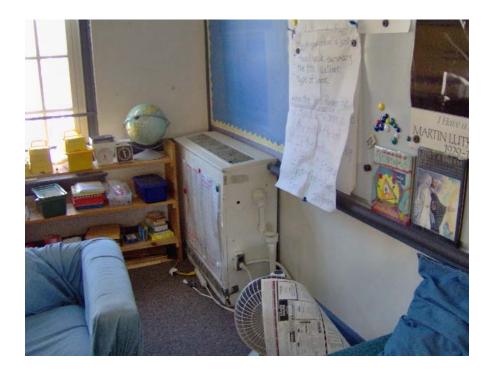
Fresh air is supplied by a unit ventilator (univent) system that appears to have been installed when the building was originally constructed (1927) (Picture 1). Within each univent is a fan and set of moveable louvers through which fresh air enters (Figure 1). Each of these louver systems appears to be set by hand to regulate fresh air intake into the univent. [Please note that efficient function of such aged equipment is difficult to maintain, since compatible replacement parts are often unavailable.]

Univent

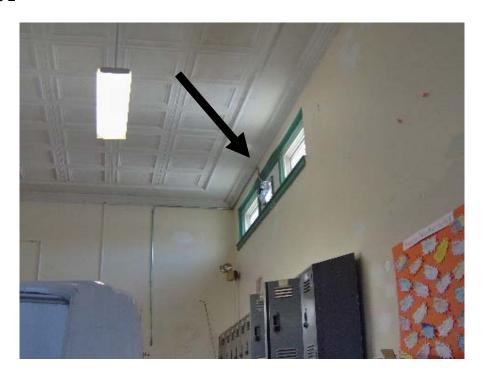
system drew air through grated holes or by closet vents located at floor level in classrooms. The exhaust vent system was sealed during the roof replacement. Without sufficient supply and exhaust ventilation, environmental pollutants can build up and lead to indoor air quality/comfort complaints. In an effort to improve air movement in the building, an exhaust vent fan was installed in a hallway window on the second floor (Picture 2).

cafeteria during food preparation. During the course of the assessment, CEH staff detected cooking odors throughout the upper floor of the building, particularly in the second floor hallway where an exhaust fan was installed (Picture 2). No local exhaust was observed for the kitchen stove and, as discussed previously, heater fans in the cafeteria were activated and hallway doors were all propped open in order to increase airflow (Picture 5). Thus the most likely source of PM2.5 measured during the assessment was from cooking odors/particulates in the kitchen being drawn to the upper floor by the newly installed fan. To confirm this hypothesis, particulate matter was re-sampled in the cafeteria and upper floor after cooking had ceased, and the cafeteria heater fans were deactivated. The highest particle level dropped to $18 \, \mu g/m^3$, which would indicate that cooking in the kitchen was the likely source of the PM2.5 level measured.

Fan Installed In 2nd Floor Hallway to Provide Exhaust Ventilation

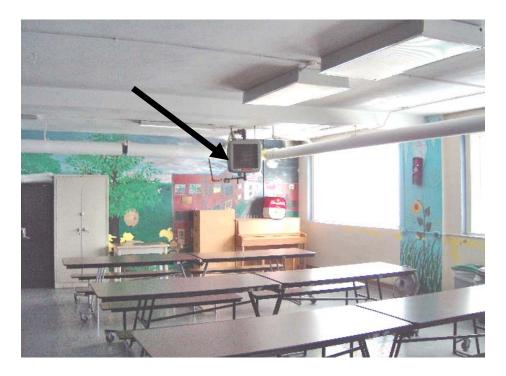
Heater Fans in Cafeteria

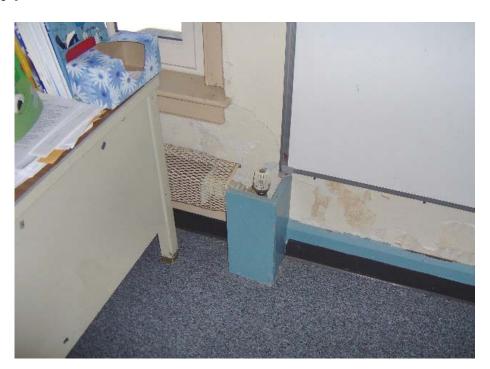
Classroom 308 had water-damaged wall plaster (Picture 4), which can indicate leaks through the window system. It is likely that this occurred prior to the replacement of the original windows. Water-damaged wall plaster can provide a medium for mold growth especially if wetted repeatedly. These types of materials should be repaired/replaced after a water leak is discovered and repaired.

Classroom 308 Had Water-Damaged Wall Plaster

- 12. Seal former chemical hood.
- 13. Ensure leaks are repaired and repair damaged wall plaster in room 308.
- 14. Relocate or consider reducing the amount of materials stored in classrooms to allow for more thorough cleaning. Clean items regularly with a wet cloth or sponge to prevent excessive dust build-up.

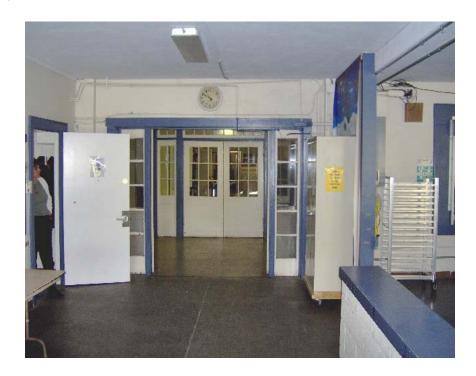
Cafeteria Hallway Doors Propped Open

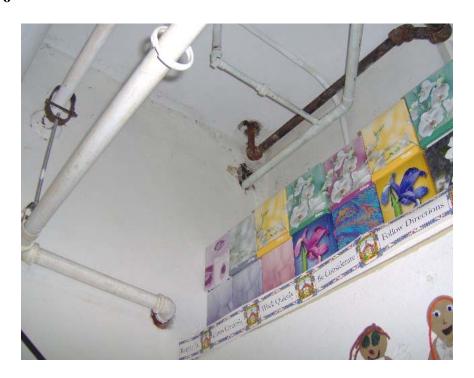
Several other conditions that can potentially affect indoor air quality were also identified. Open utility holes were observed in several areas (Picture 6). Open utility holes can provide pathways for drafts, dust, odors and moisture between rooms and floors. One classroom contained an abandoned chemical hood (Picture 7). The termini of this hood (Picture 8) should be permanently sealed to prevent backdrafting into the classroom.

Example Of Open Pipe Hole In Wall

- 9. Discontinue the use of tennis balls on classroom chairs and desks.
- 10. Ensure that all restroom exhaust systems are vented directly outdoors.
- 11. Seal utility holes in walls.

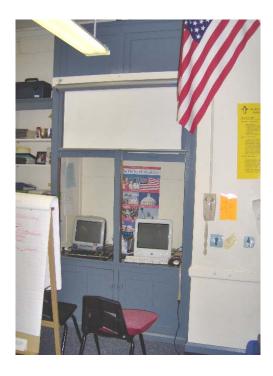
Former Chemical Hood

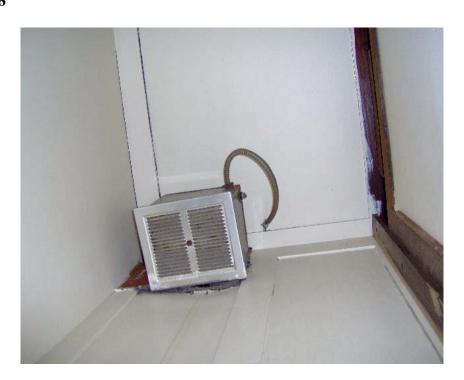
Vent In Former Chemical Hood
